## Design and execution of restoration work on a low-water crossing platform with a reinforced concrete structure

This study aims to take a descriptive approach to the entire process involved in restoring the Pau Ferro District Low-Water Crossing, located in Salgueiro,

Pernambuco, Brazil. The case study in question deals with a public project located on a state highway, which is a secondary unpaved road called the Estrada do Pau Ferro. The restoration was carried out on a structure characterized as being part of the special projects group, which includes bridges, viaducts, and footbridges, for example.

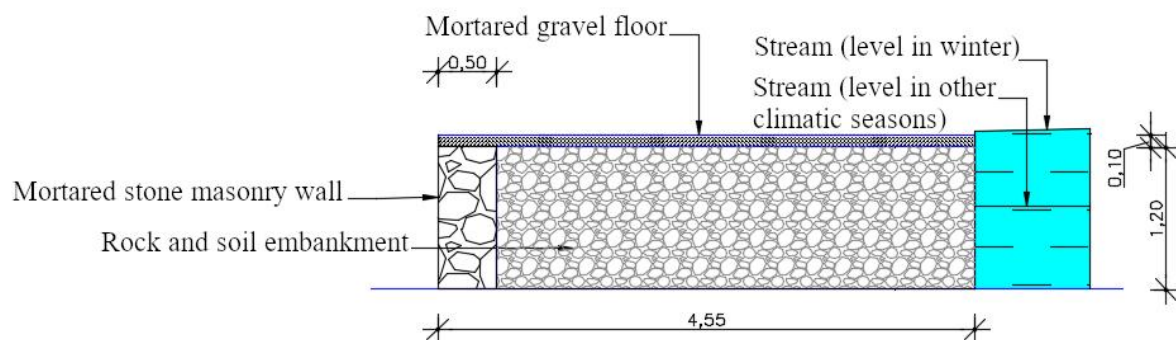
**Figure 1** - Detail of a cross-section (at meter 41) of the Pau Ferro low-water crossing during its construction in the 1970s, measurements in meters.

The low-water crossing was built in the mid-1970s. It was constructed using a simple method that consisted of a rock and soil embankment, with a mortared stone masonry retaining wall, and a layer of compacted and mortared gravel that would serve as a floor, as shown in Figure 1.

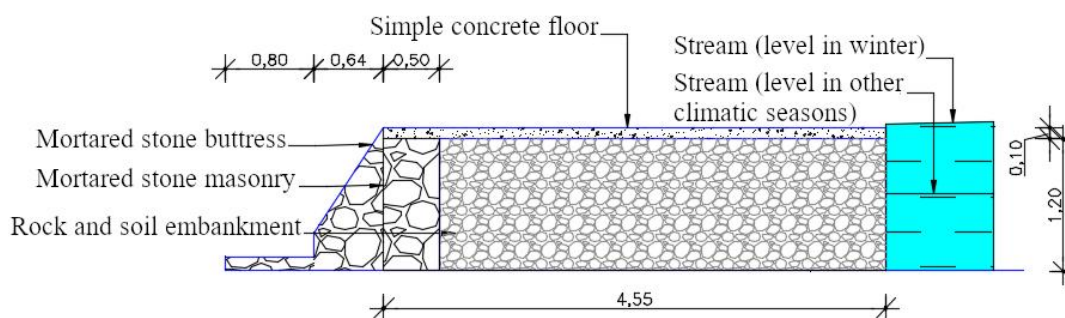
**Figure 2** - Detail of a cross-section (at meter 41) of the Pau Ferro low-water crossing after renovations in the 1980s and 1990s, up to the year 2021, measurements in meters.

During the 1980s and 1990s, in addition to periodic maintenance, the crossing underwent more extensive repairs, including the addition of buttresses every 4 four meters, to the existing structural wall, as well as the installation of a simple concrete floor to replace the mortared gravel, as can be seen in Figure 2. This configuration of the low-water crossing remained in place until 2021, with only periodic maintenance.

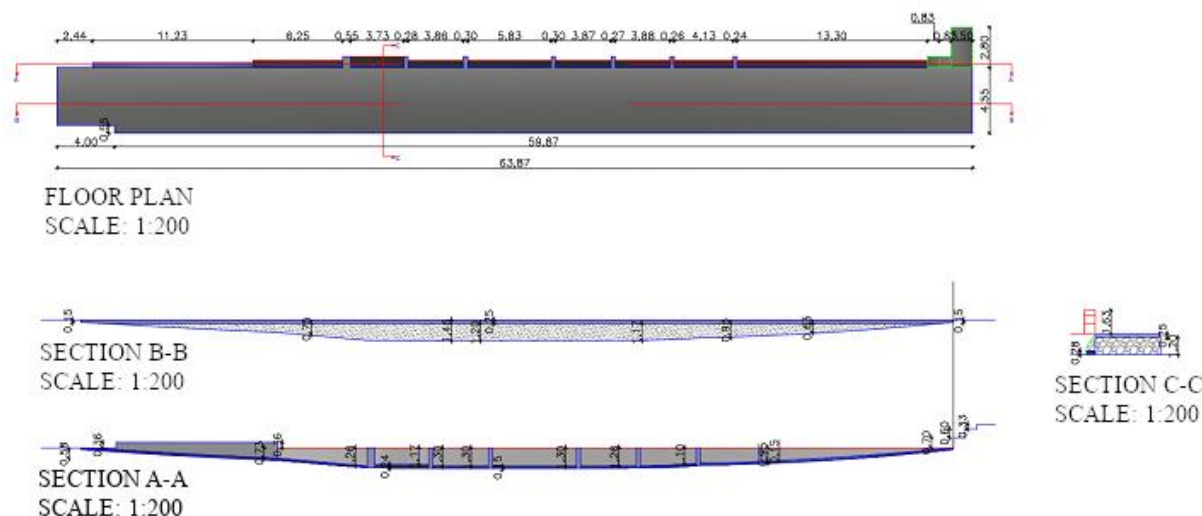
**Figure 3** - Floor plan and sections as collected during the inspection, measurements in meters.

The road was highly deteriorated, making it difficult for motorcycles and pedestrians to pass. Accidents had already been reported at the site. The simple concrete floor had been worn down, mainly due to the high traffic of heavy vehicles and the constant flow of water, which had damaged it through the abrasion effect.

Part of the rockfill located between meters 60 and 64 had collapsed and, in some stretches along the roadway, slumping had occurred. The absence of a structural wall on the left-hand side, in the direction of Pau Ferro, was something notable, as it could not have been in full working order due to its size, being a rockfill, or partially rockfill, low-water crossing (since there was only one wall). Figure 3 shows a schematic of the crossing's sections and the situation observed during the inspection on January 20th, 2021.

After the completion of the inspection and analysis of what was observed on site and the history of the structure, it was found that immediate intervention was necessary. This time the renovation would require a more severe intervention compared to the maintenance that had been done over the years.
